Where is the Ordinary High Water Mark of a River?

The Ordinary High Water Mark in the Chagrin River Watershed

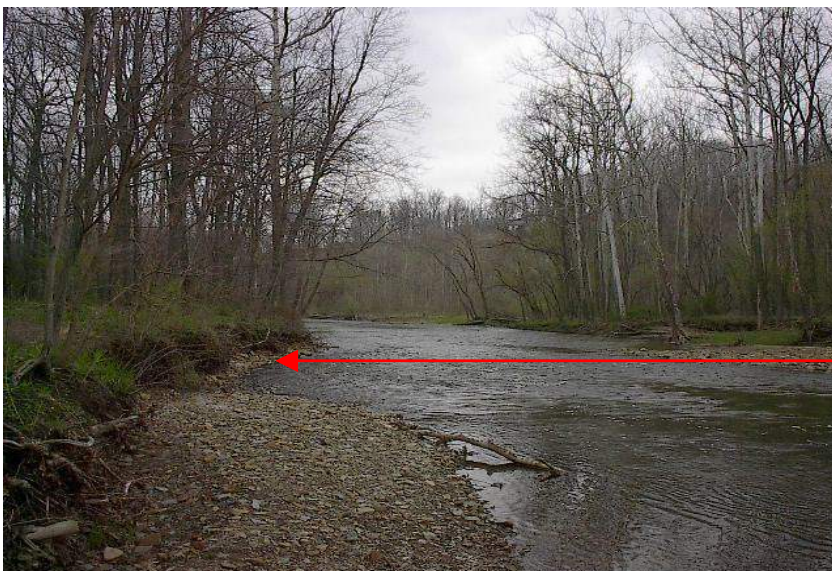
Figure 1: South Chagrin Reservation, Village of Bentleyville

The ordinary high water mark on this section of the Chagrin River is clear at the point where gravel meets terrestrial grasses along the stream bank.

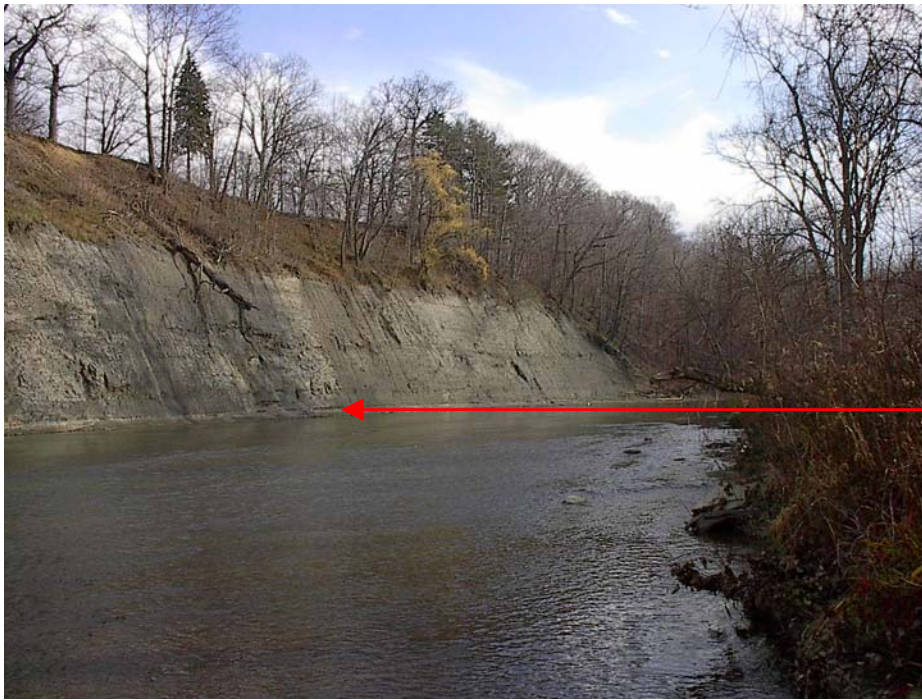
Figure 2: Todd Field, City of Willoughby

This horizontal line along the bottom of this steep bank shows the ordinary high water mark. On this section of the Chagrin River, active erosion defines the area.

In areas with steep banks, an erosion scour line usually highlights the ordinary high water mark.

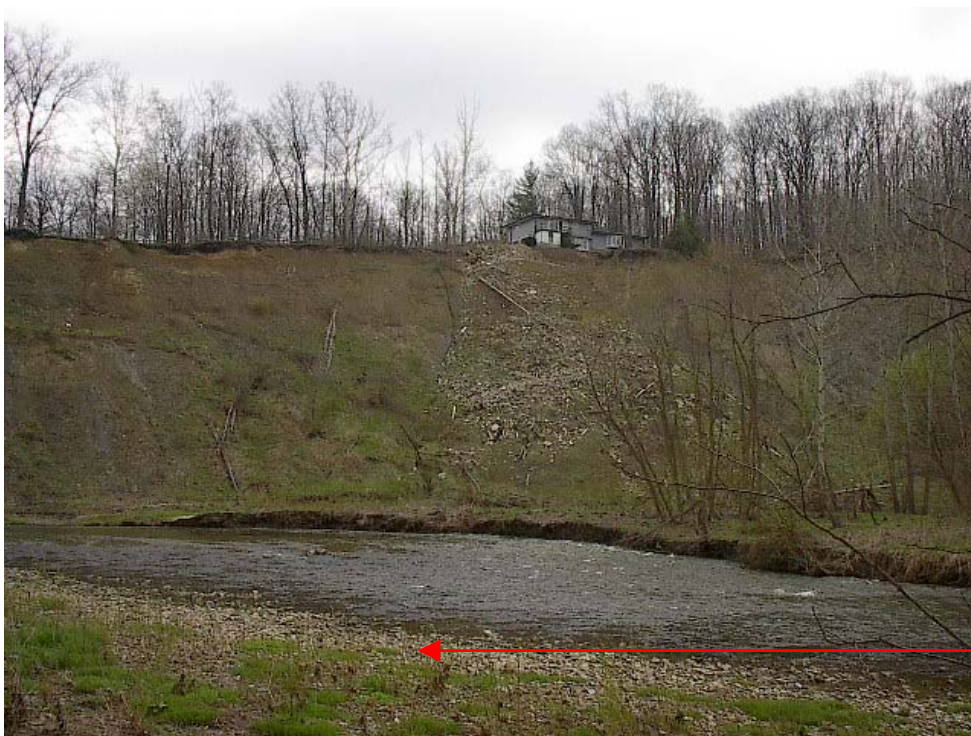
Figure 3: Village of Moreland Hills

This ordinary high water mark area highlights a transition between aquatic plants and terrestrial plants.
